## BELZONA REPAIRS AND PROTECTS SULPHURIC ACID BUND

Power Station, UK

Secondary containment for two acid tanks in the water treatment section. The top tank contains 98% Sulphuric Acid which feeds into a lower tank diluted to 10% strength. and used in the water treatment process

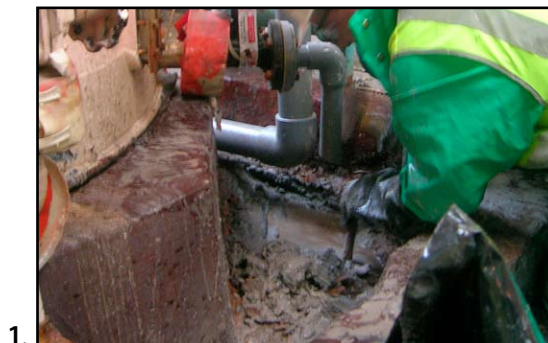
Malfunction in the system caused a quantity of 98% Acid to be dropped, followed by a quantity of distilled water. The resultant exothermic reaction was so rapid it stripped the original coating off the concrete substrate throughout the containment area.

1. Damaged tank pad
2. Rebuilding with Belzona<sup>®</sup> 4111
3. Rebuilding complete
4. Tank pad protected with Belzona<sup>®</sup> 4311
