SPALLED CONCRETE VAULTS ARE RECONSTRUCTED WITH BELZONA®

Natural Gas Processing Plant in New Mexico, U.S.A.

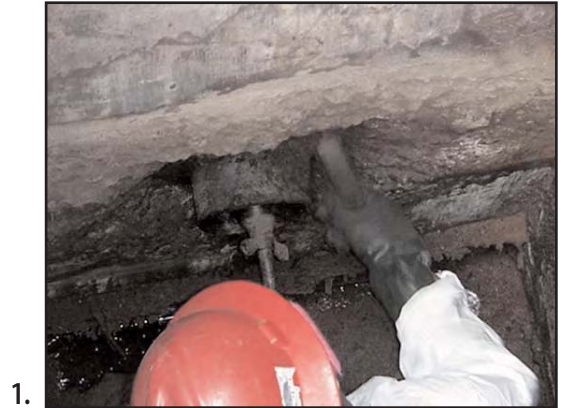
Over the years the different thermal expansion characteristics of the pipes caused the concrete surrounding pipes in the vault to spall.

1. Some of the spalls were 8 inches deep.
2. Belzona® 4911 applied, application of Belzona® 4141 in progress.
3. Admiring the reconstructed unit.
