Application Focus

Erosion-Corrosion *Heat Exchangers*

Application Case Study

Heat Exchanger Repair & Protection Solution

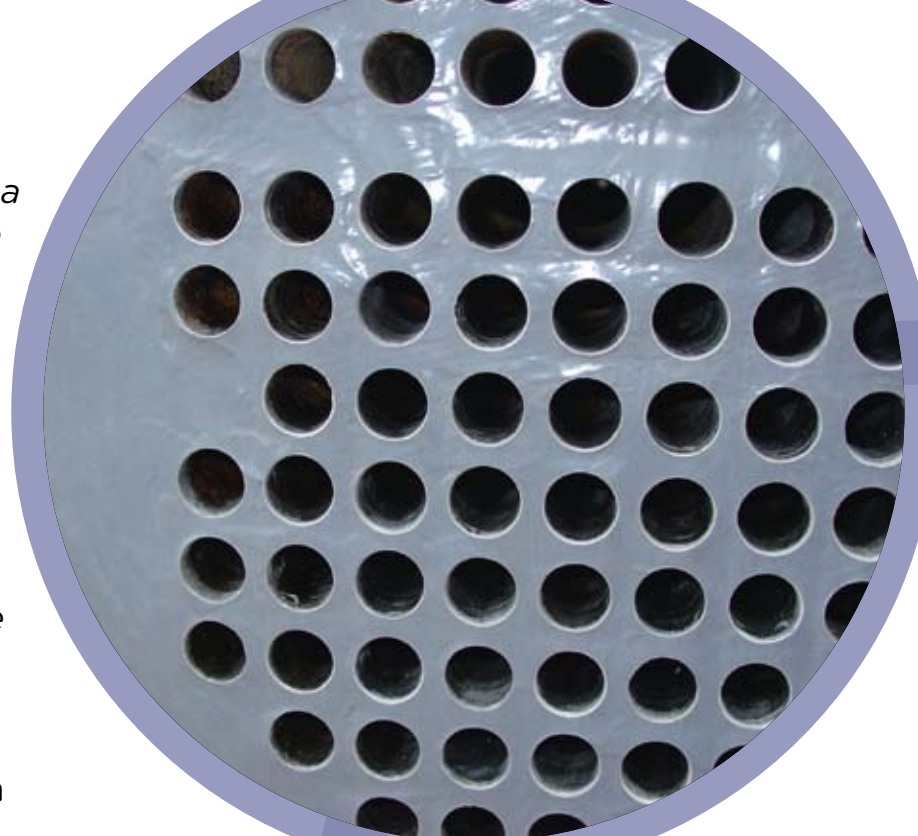
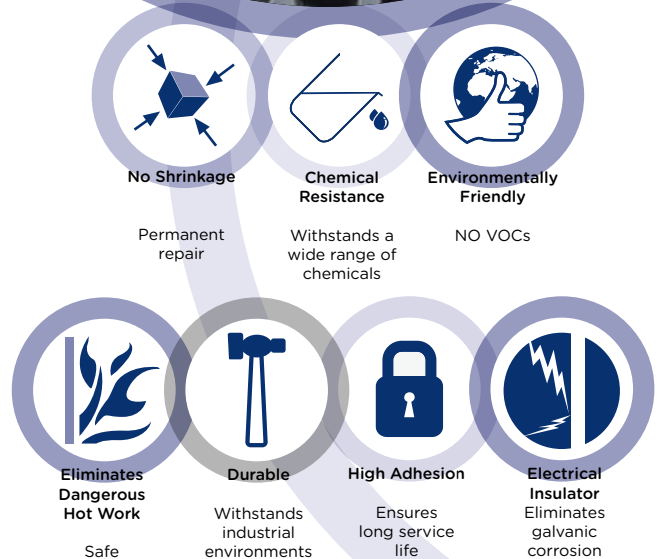
“ A customer was faced with a potentially high cost maintenance repair due to severe damage to multiple components within a heat exchanger. Following inspection, it was found that galvanic corrosion coupled with erosion had caused a loss of metal thickness on the tubesheet surface. Consequently, coolant was able to contaminate the process fluid, necessitating immediate shutdown of the system. ”

Belzona provided a cost effective solution that not only rebuilt the eroded tubesheet and sealed the leaks but prevented future corrosion. The electrically insulating Belzona materials isolated the dissimilar metals used in the heat exchanger construction so eliminating further galvanic corrosion.

The heat exchanger was quickly returned to service with the full supply and fix costs for this solution a fraction of the estimated replacement costs. During a five year maintenance outage the heat exchanger was inspected and found to be in excellent operational condition.
