Des Moines Water Works Saves With Belzona

3E recently repaired and coated three large pumps in two different applications at the Des Moines Water Works (DMWW) using Belzona products. The end result of both repairs was a significant savings for the customers of DMWW.

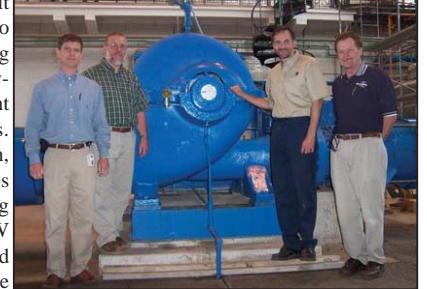
Left to right; Ted Corrigan, Doug Oscarson, both of DMWW, Dave Van Blarcom (3E) and Mark Anderson (Belzona)
