Application Focus

Erosion-Corrosion *Fluid Handling Equipment*

Application Case Study

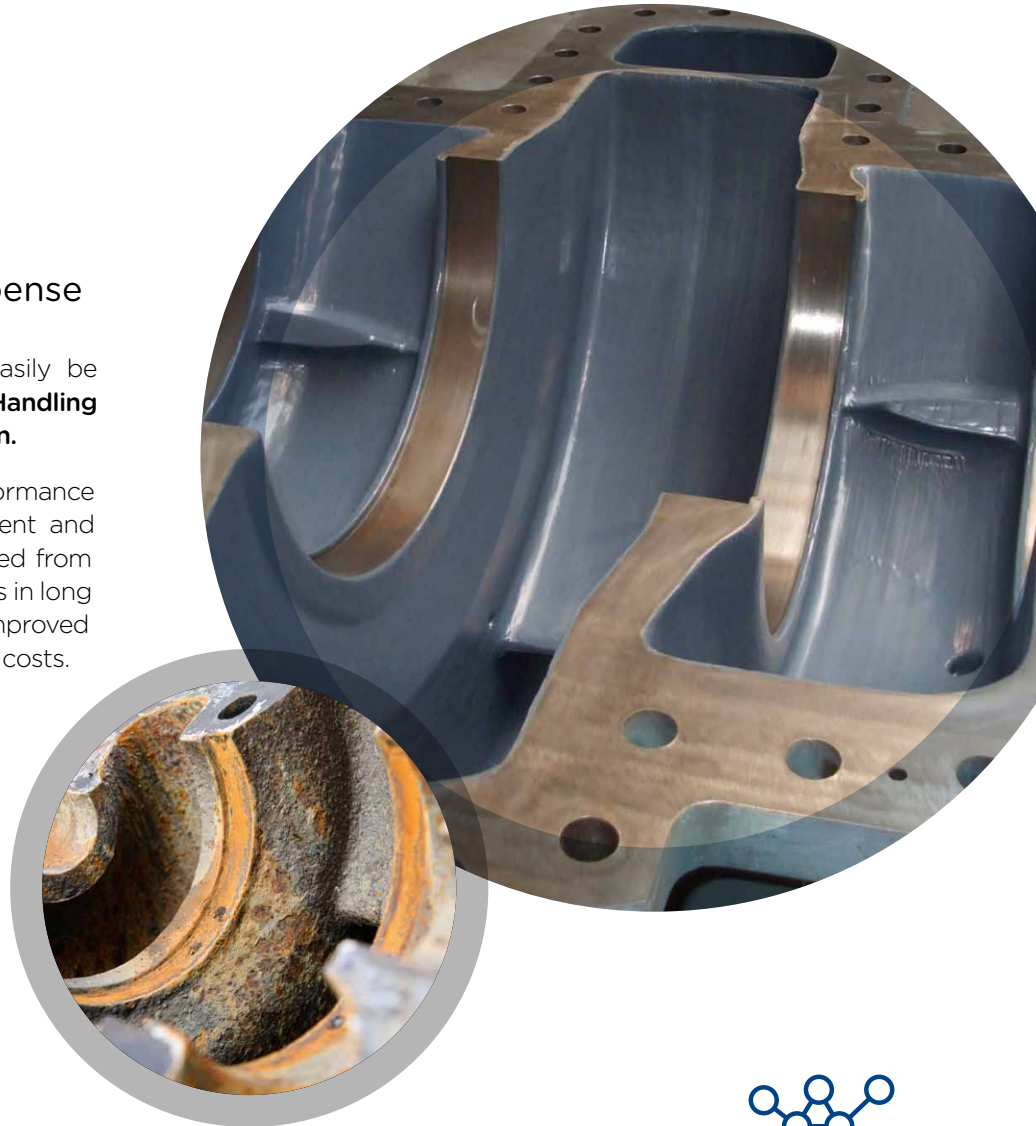
“ An inspection of a cooling water pump found the impeller to be suffering from severe cavitation. The damage was so extensive that the impeller had eroded to the point of requiring complete replacement. ”

Belzona® provided a cost effective solution to repair the impeller, prevent further deterioration and reduce future cavitation. Firstly, a stainless steel mesh was used to reform the vanes. After rebuilding using a Belzona® polymer repair composite to obtain original profiles, the impeller was coated to provide further cavitation resistance.

Finally, the Belzona® solution returned the cooling water pump to service within three days, ensuring minimal downtime and disruption to the operations team. A replacement unit would have taken six days to arrive on-site with further machining required.
